MINUTES OF MEETING OF INSPECTION (WEST DISTRICT) HELD ON 06.06.2023 BY THE COMMITTEE APPOINTED BY THE HON'BLE HIGH COURT

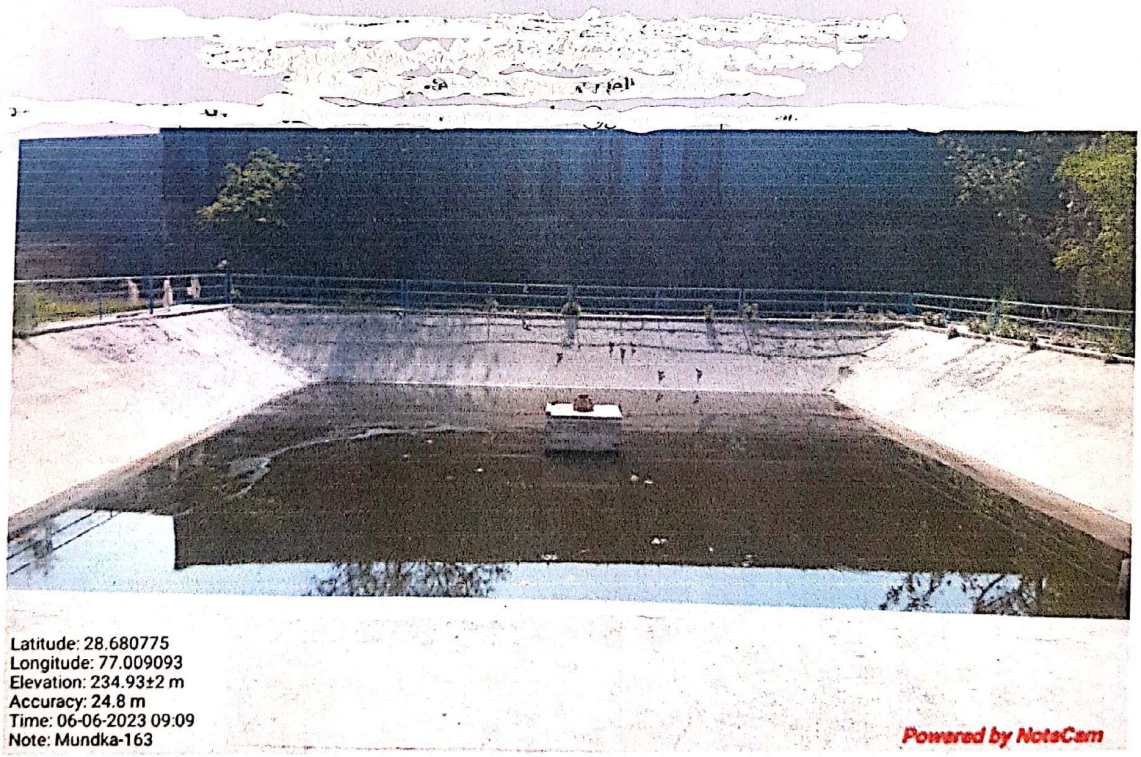
Khasra No. 163 (4-16) Dada Dhobas Johar

It belongs to DDA. In most of the part of this area we find construction and very less part from the area earmarked for water body has been left out as open. Even the pond constructed is artificial and no water is seeping/going under the ground. It is also noticed that water is pumped out through tube well, which is the only source of water for the entire area.

Be that as it may no further construction shall be permitted and what is to be done for the existing construction will be seen later on. Endeavour should be made to have the catchment of water from outside road as well and plan to that affect be prepared an action be also under taken, as far as possible for collecting the water. Report be submitted on or before 24.07.2023 on email – vivekkumartandon@gmail.com, tandonadvocates@gmail.com.

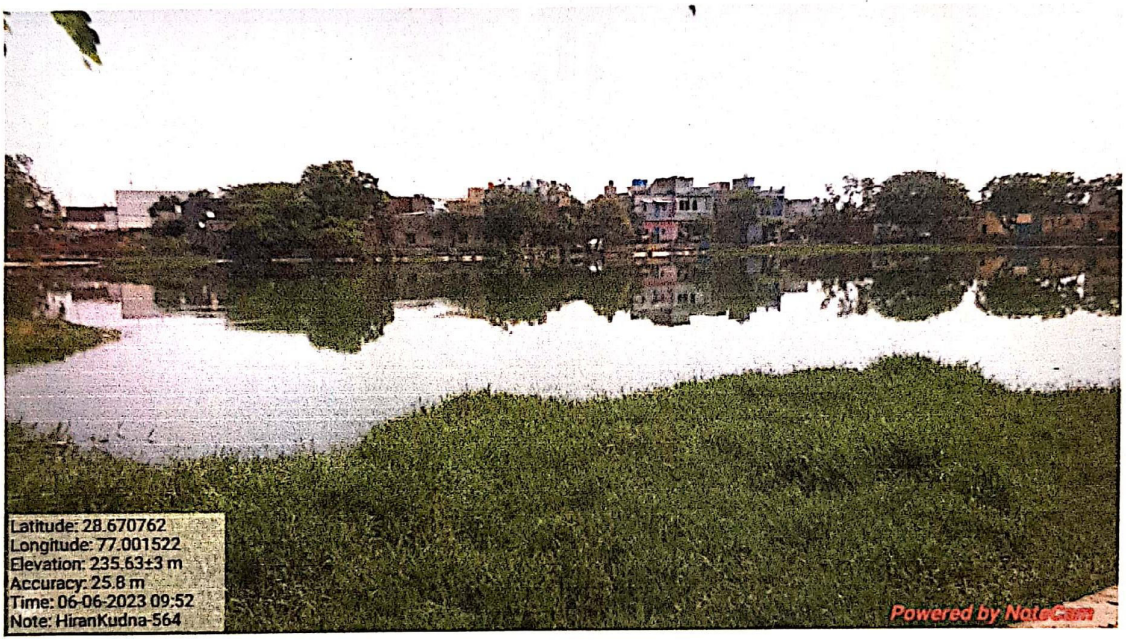
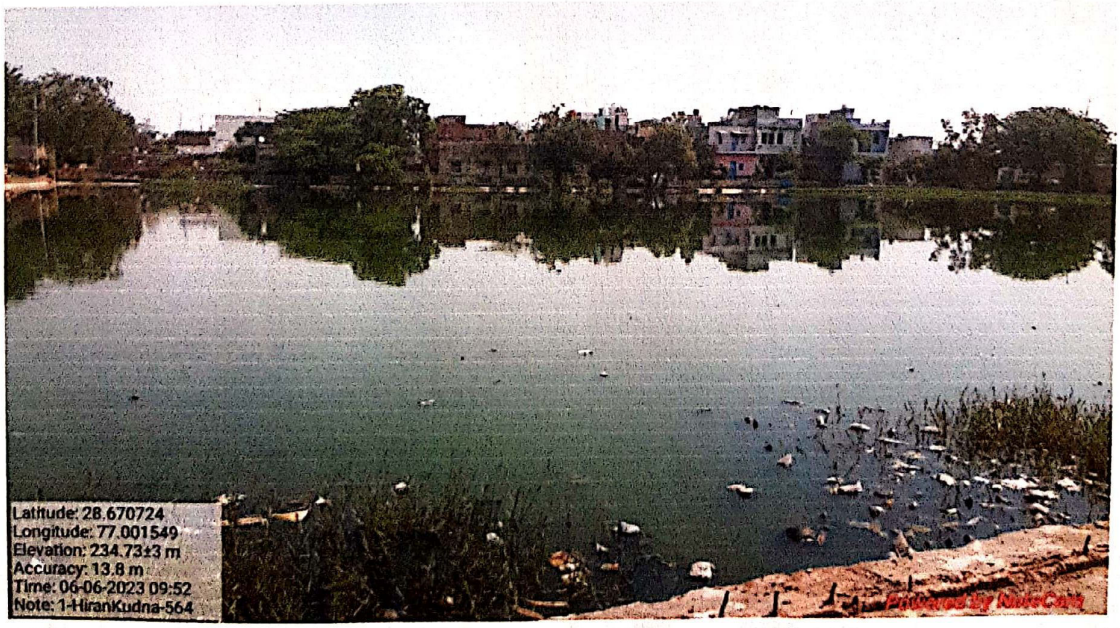
Khasra No. 564 (16-05)

It belongs to DDA. Immediate steps to block the sewage is required to be undertaken. The water body needs cleaning immediately. It is also noticed that garbage is being thrown into this water body. A Notice board be installed indicating the area of the water body and also that in

case anybody is found throwing garbage or otherwise shall be challaned. The entire process be completed before the rainy season and proposed action as well as after completion be forwarded along with photographs (before and after) within one month.

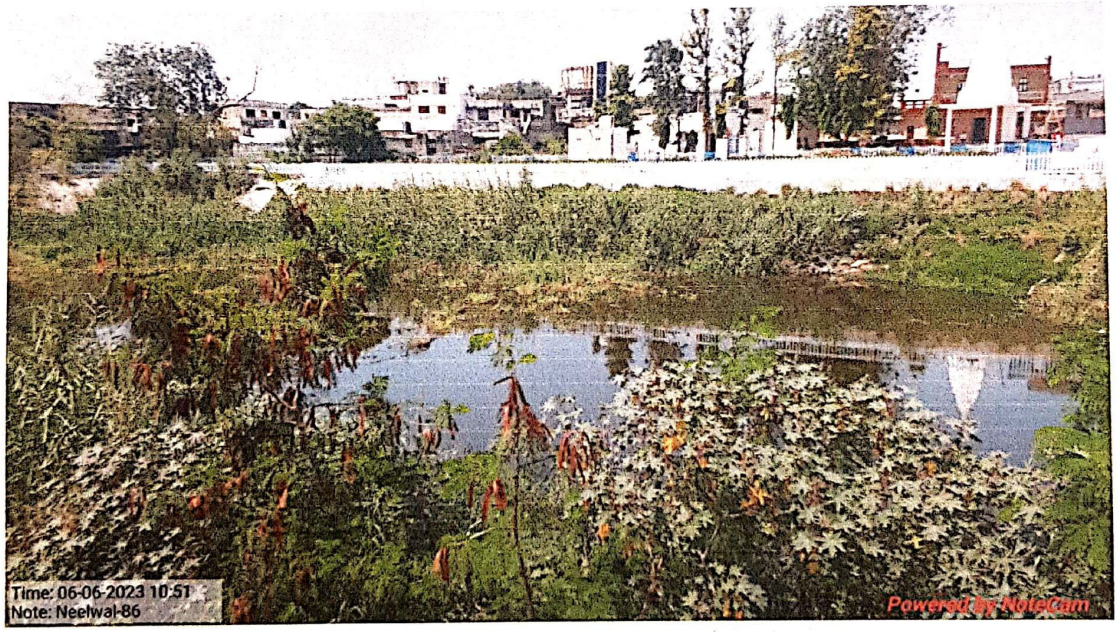
Khasra No. 86 (08-11)

It belongs to DDA. Though it is reported that STP plant has been set up by Delhi Jal Board and is in working condition. However, none was present from the Delhi Jal Board to apprise actual facts. Further the cleaning of water body is extremely necessary which should be done on a war footing basis. Report be submitted by 26.06.2023 on email – vivekkumartandon@gmail.com, tandonadvocates@gmail.com.

Exact demarcation be done so that it is encroachment free and if any encroachment is found the same may be removed immediately.

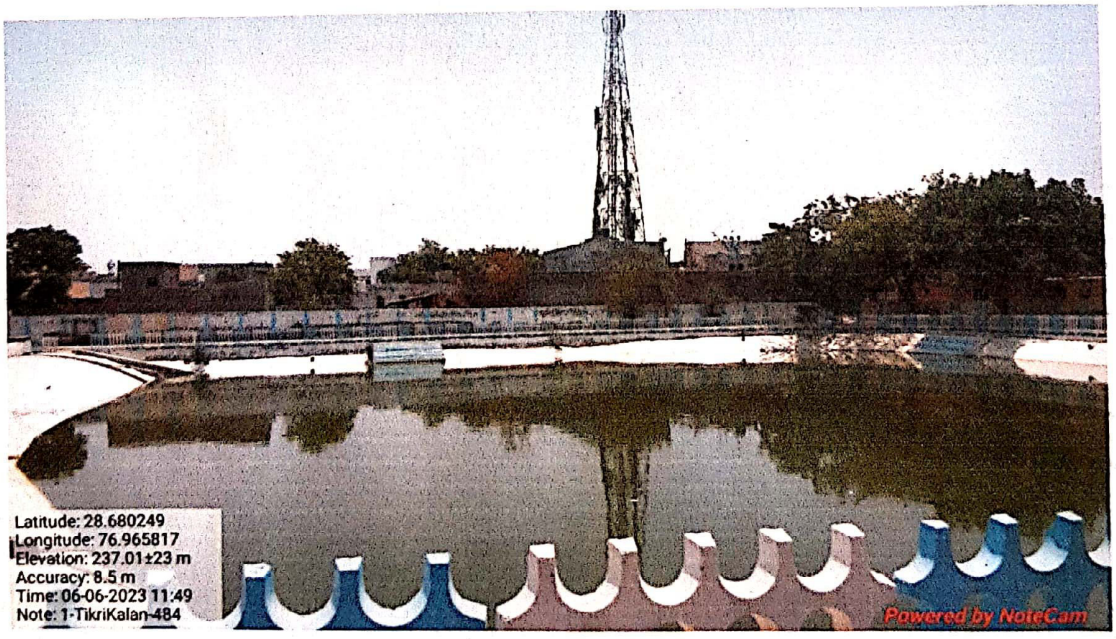
Khasra No. 484min (6-14-1/2)1213 (0-3) Total Area (6-17-1/2)

After a long time a well maintained water body is found. However after going through the records it is found that outlet of water contains 20 BOD which is alarming. Efforts be made to reduce the said BOD as even after pilfiltration the same water be harmful when it meets underground water. The Delhi Jal Board have assured to bring

it to 10 BOD in a short span of time which too is on a higher side. Action Plan/Report be submitted within 2 weeks on email – vivekkumartandon@gmail.com, tandonadvocates@gmail.com.

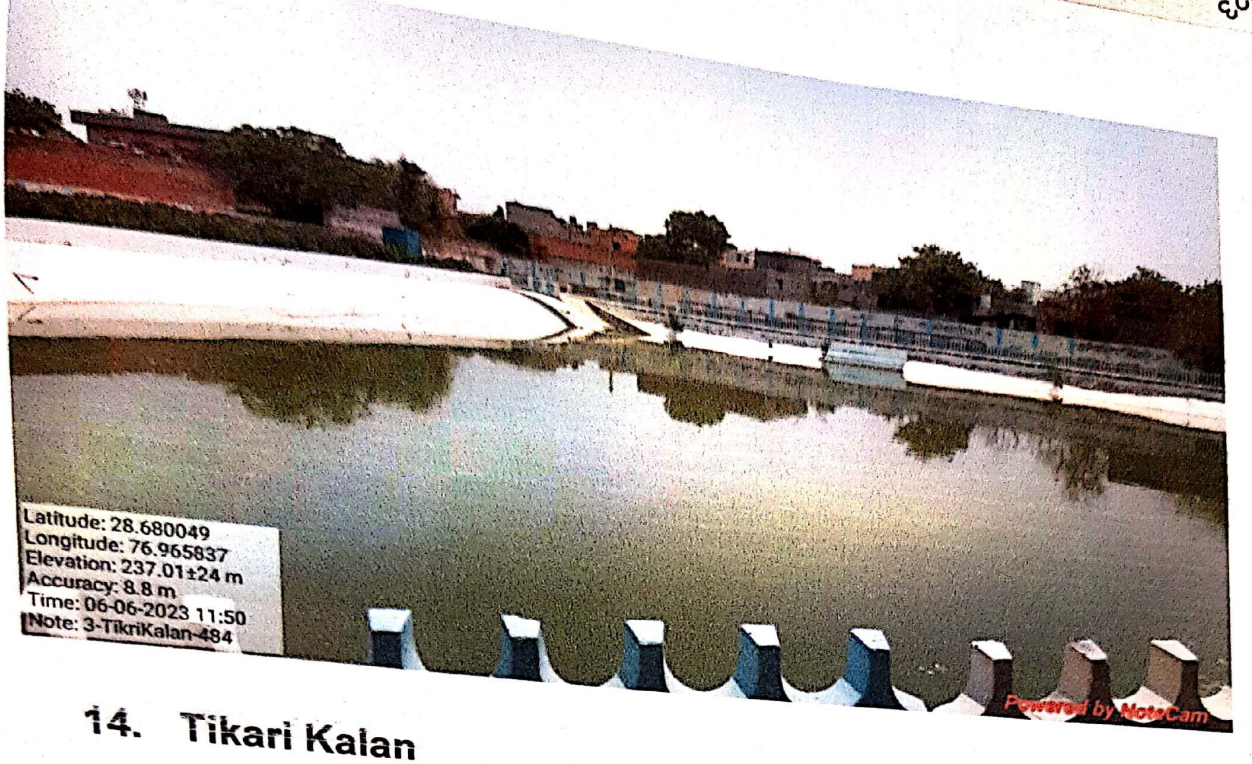
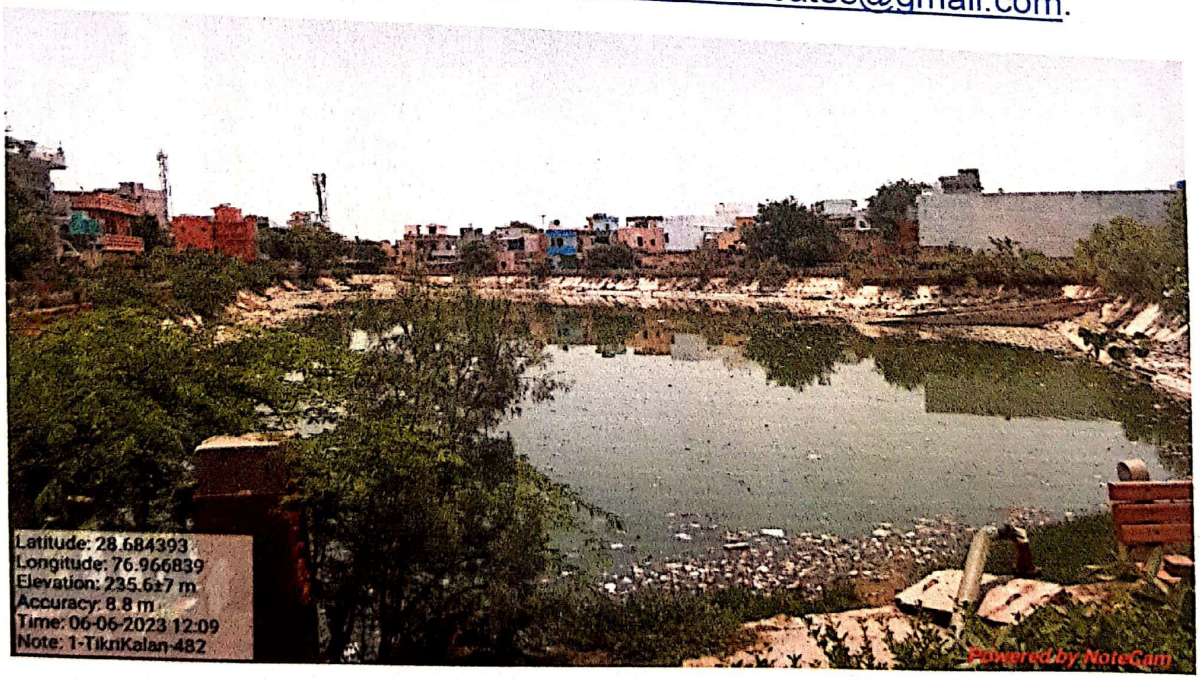
Khasra No. 482min (19-7-1/2)

At site it was found that water is being dragged out through pumping machine and the water was being taken to Mungeshpur drain. The DDA to prepare a plan/scheme for development of water body within one month and report be submitted by 24.07.2023 on email – vivekkumartandon@gmail.com, tandonadvocates@gmail.com.

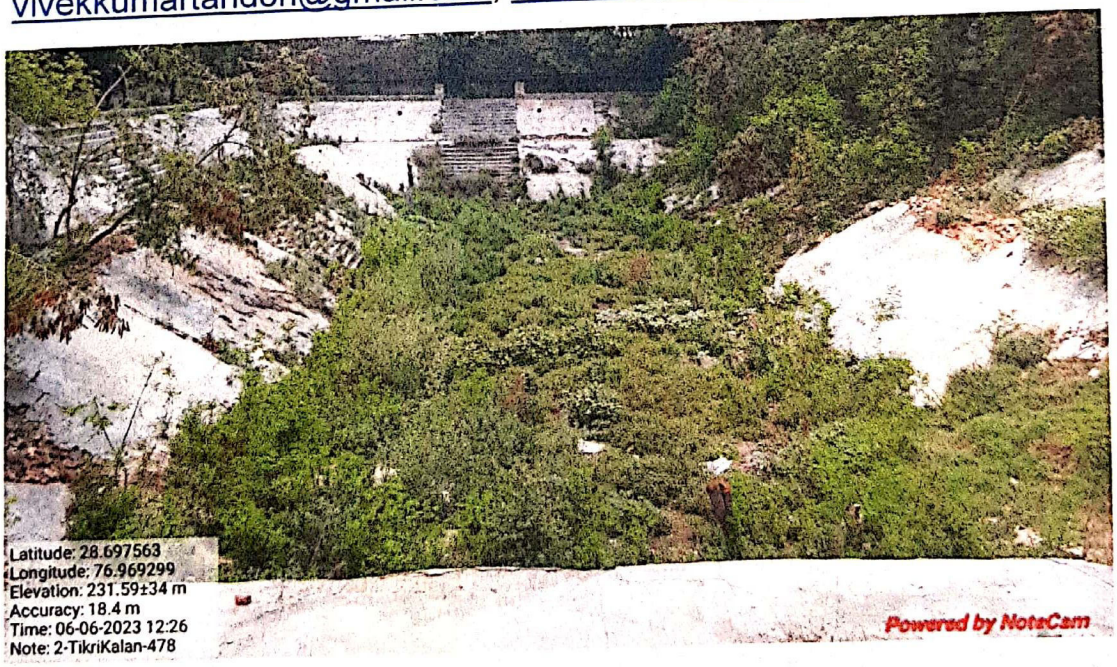
Khasra No. 478 (5-6)

It belongs to DDA. The condition of the water body is pathetic and needs immediate repairing and cleaning. Further, how it would be maintained should also be indicated.

Action Plan be prepared and submitted by 24.06.2023 on email – vivekkumartandon@gmail.com, tandonadvocates@gmail.com.
